Repair Kit
BREMI 20113/40

Maintenance recommendation

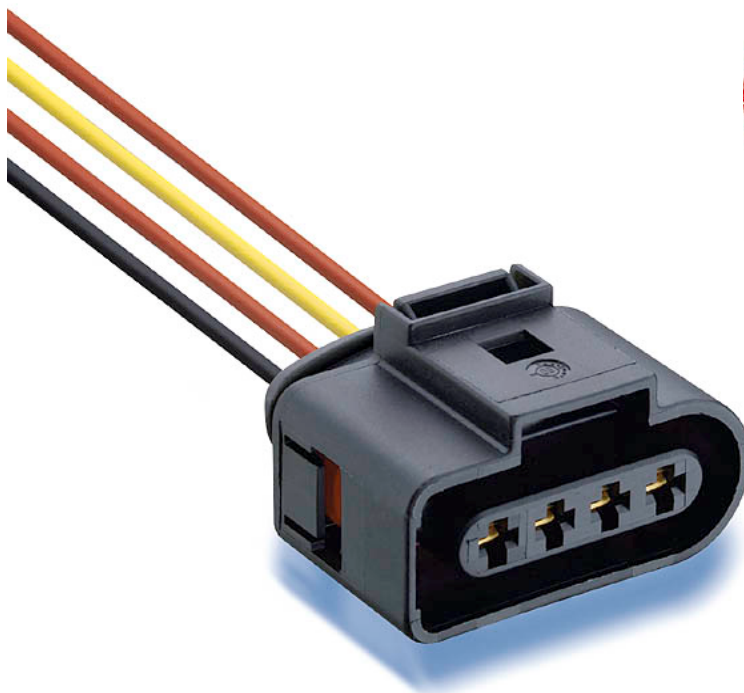
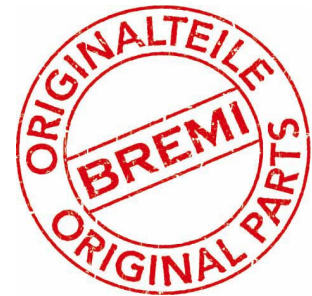
When replacing the ignition coils listed below please also check the connection cables leading to the ignition coils:

Should cracks in the insulation of the connection cables be visible we recommend using the repair kit 20113/40.

Should one or more pin(s) of the connector of the connection cable show signs of oxidization or if the connectors are no longer locked correctly we recommend using the repair kit 20113/40.

A damaged connection cable can damage the ignition coil.

By using the repair kit 20113/40 recurring repairs to the connection cables and to the ignition coils can be avoided.

Cable:

Color code: yellow
Core insulation: ETFE
Temperature range: -40°C to 150°C
Cross section: Ø 1,0 mm

Color code: black / brown
Core insulation: ETFE
Temperature range: -40°C to 150°C
Cross section: Ø 1,5 mm

Single core insulation:

- prevents the penetration of impurities and humidity along the cable guide

Crimping contact:

Pins: gold plated

Flat connector housing:

Material: PBT, black
Safety clip: PBT, violet (prevents the loosening of the crimping inside the connector)
Gasket: to seal against impurities and humidity
